City of Greenville Meetinghouse Branch Watershed Master Plan

MEETINGHOUSE BRANCH WATERSHED MASTER PLAN

October 2013

Prepared by
W. K. Dickson & Co., Inc.
Raleigh, NC
919/782/0495
NC License Number: F-0374

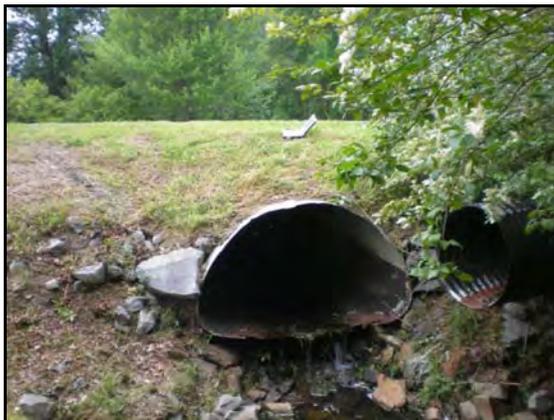
Picture 3-1. Bells Branch: East 14th Street – Downstream Pipe

Location	Size/Material	Condition
Bells Branch		
East 14 th Street	48" CMP	Poor – Pipe Collapsed with Rusted Invert
Quail Ridge Road	Twin 54" CMP	Fair
York Road	60" CMP	Fair
Railroad Crossing	60" RCP	Fair – Misaligned Joints with Visible Rebar
Kensington Drive	Precast Girder Bridge	Fair/Good
Oxford Road	60" CMP	Poor – Rusted Bottom and Sinkholes Developing
Meetinghouse Branch		
Charles Boulevard	Twin 48" RCP	Good
Tucker Drive	60" CMP and 72" CMP	Good – 60" CMP Partially Obstructed by Sediment
14 th Street	Twin 60" CMP	Poor – Pipe Crushed at Invert
King George Road	Precast Girder Bridge	Poor
Railroad Crossing	Trestle Bridge	Fair
Oxford Road South	Precast Arch Bridge	Good
Oxford Road North	Precast Girder Bridge	Fair

East 14th Street – The 48" corrugated metal pipe (CMP) culvert at this crossing is in poor condition and is providing between a 2- and 10-year level of service. Consequently, it is recommended that this culvert be replaced. The recommended alternative includes replacing the existing culvert with twin 42" reinforced concrete pipe (RCP) and providing the desired 50-year level of service. Additional alternatives including floodplain benching were investigated at this location, but the other alternatives did not provide significant cost savings or increased benefits.

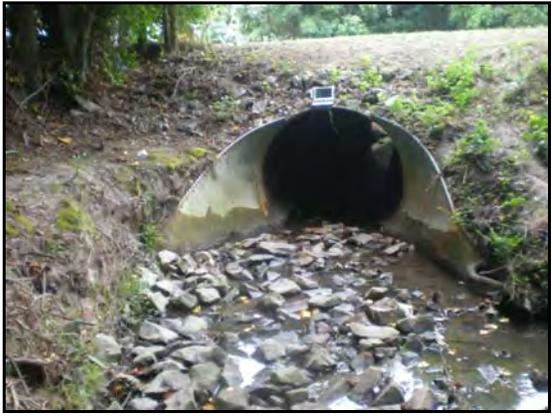
Picture 3-8. Meetinghouse Branch: Tucker Drive – Downstream Pipe (Right Side Looking Downstream)

Tucker Drive – The 60" and 72" CMP at this crossing is in good condition with the exception that the 60" culvert is approximately 50% filled with sediment. If the culvert is cleaned out then Tucker Drive crossing would provide a 25-year level of service. Therefore, no capital improvements at this location are proposed.

noted that the Tucker Drive culvert was modeled partially blocked since the opening of the 60" CMP is obstructed by sediment deposits.

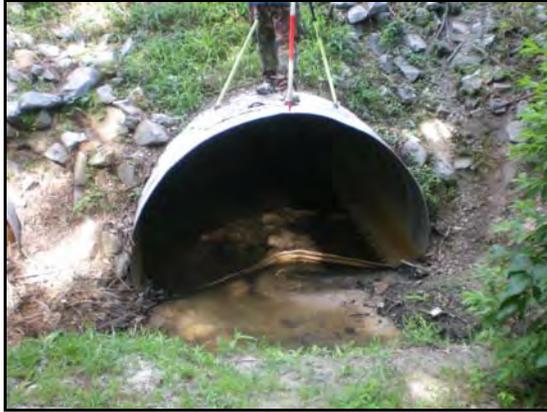
Picture 3-9. Meetinghouse Branch: 14th Street Culvert – Upstream Face (Right Side Looking Downstream)

14th Street – The twin 60" CMP at this crossing is currently providing less than a 2-year level of service and is in poor condition. Consequently, it is recommended that this culvert be replaced. The desired level of service at this location is the 50-year storm, however due to high flows, limited space, and existing erosion concerns downstream the proposed alternatives both provide a 25-year level of service which will significantly reduce flooding at this location.

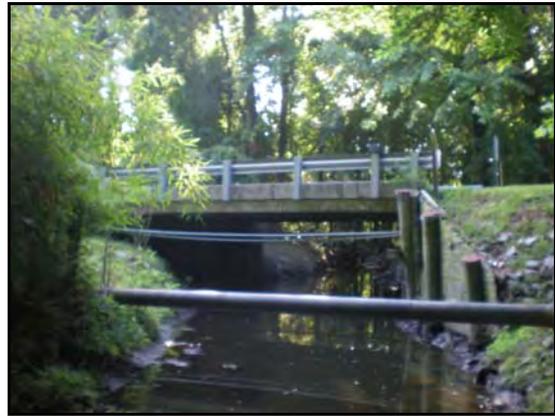
Picture 3-12. Meetinghouse Branch: Oxford Road North – Upstream Face

Oxford Road North – The existing bridge at the northern crossing along Oxford Road meets the desired 25-year level of service. However during a routine NCDOT inspection, several issues were identified. It is recommended that issues be resolved as outlined in the bridge inspection report (See Appendix L).

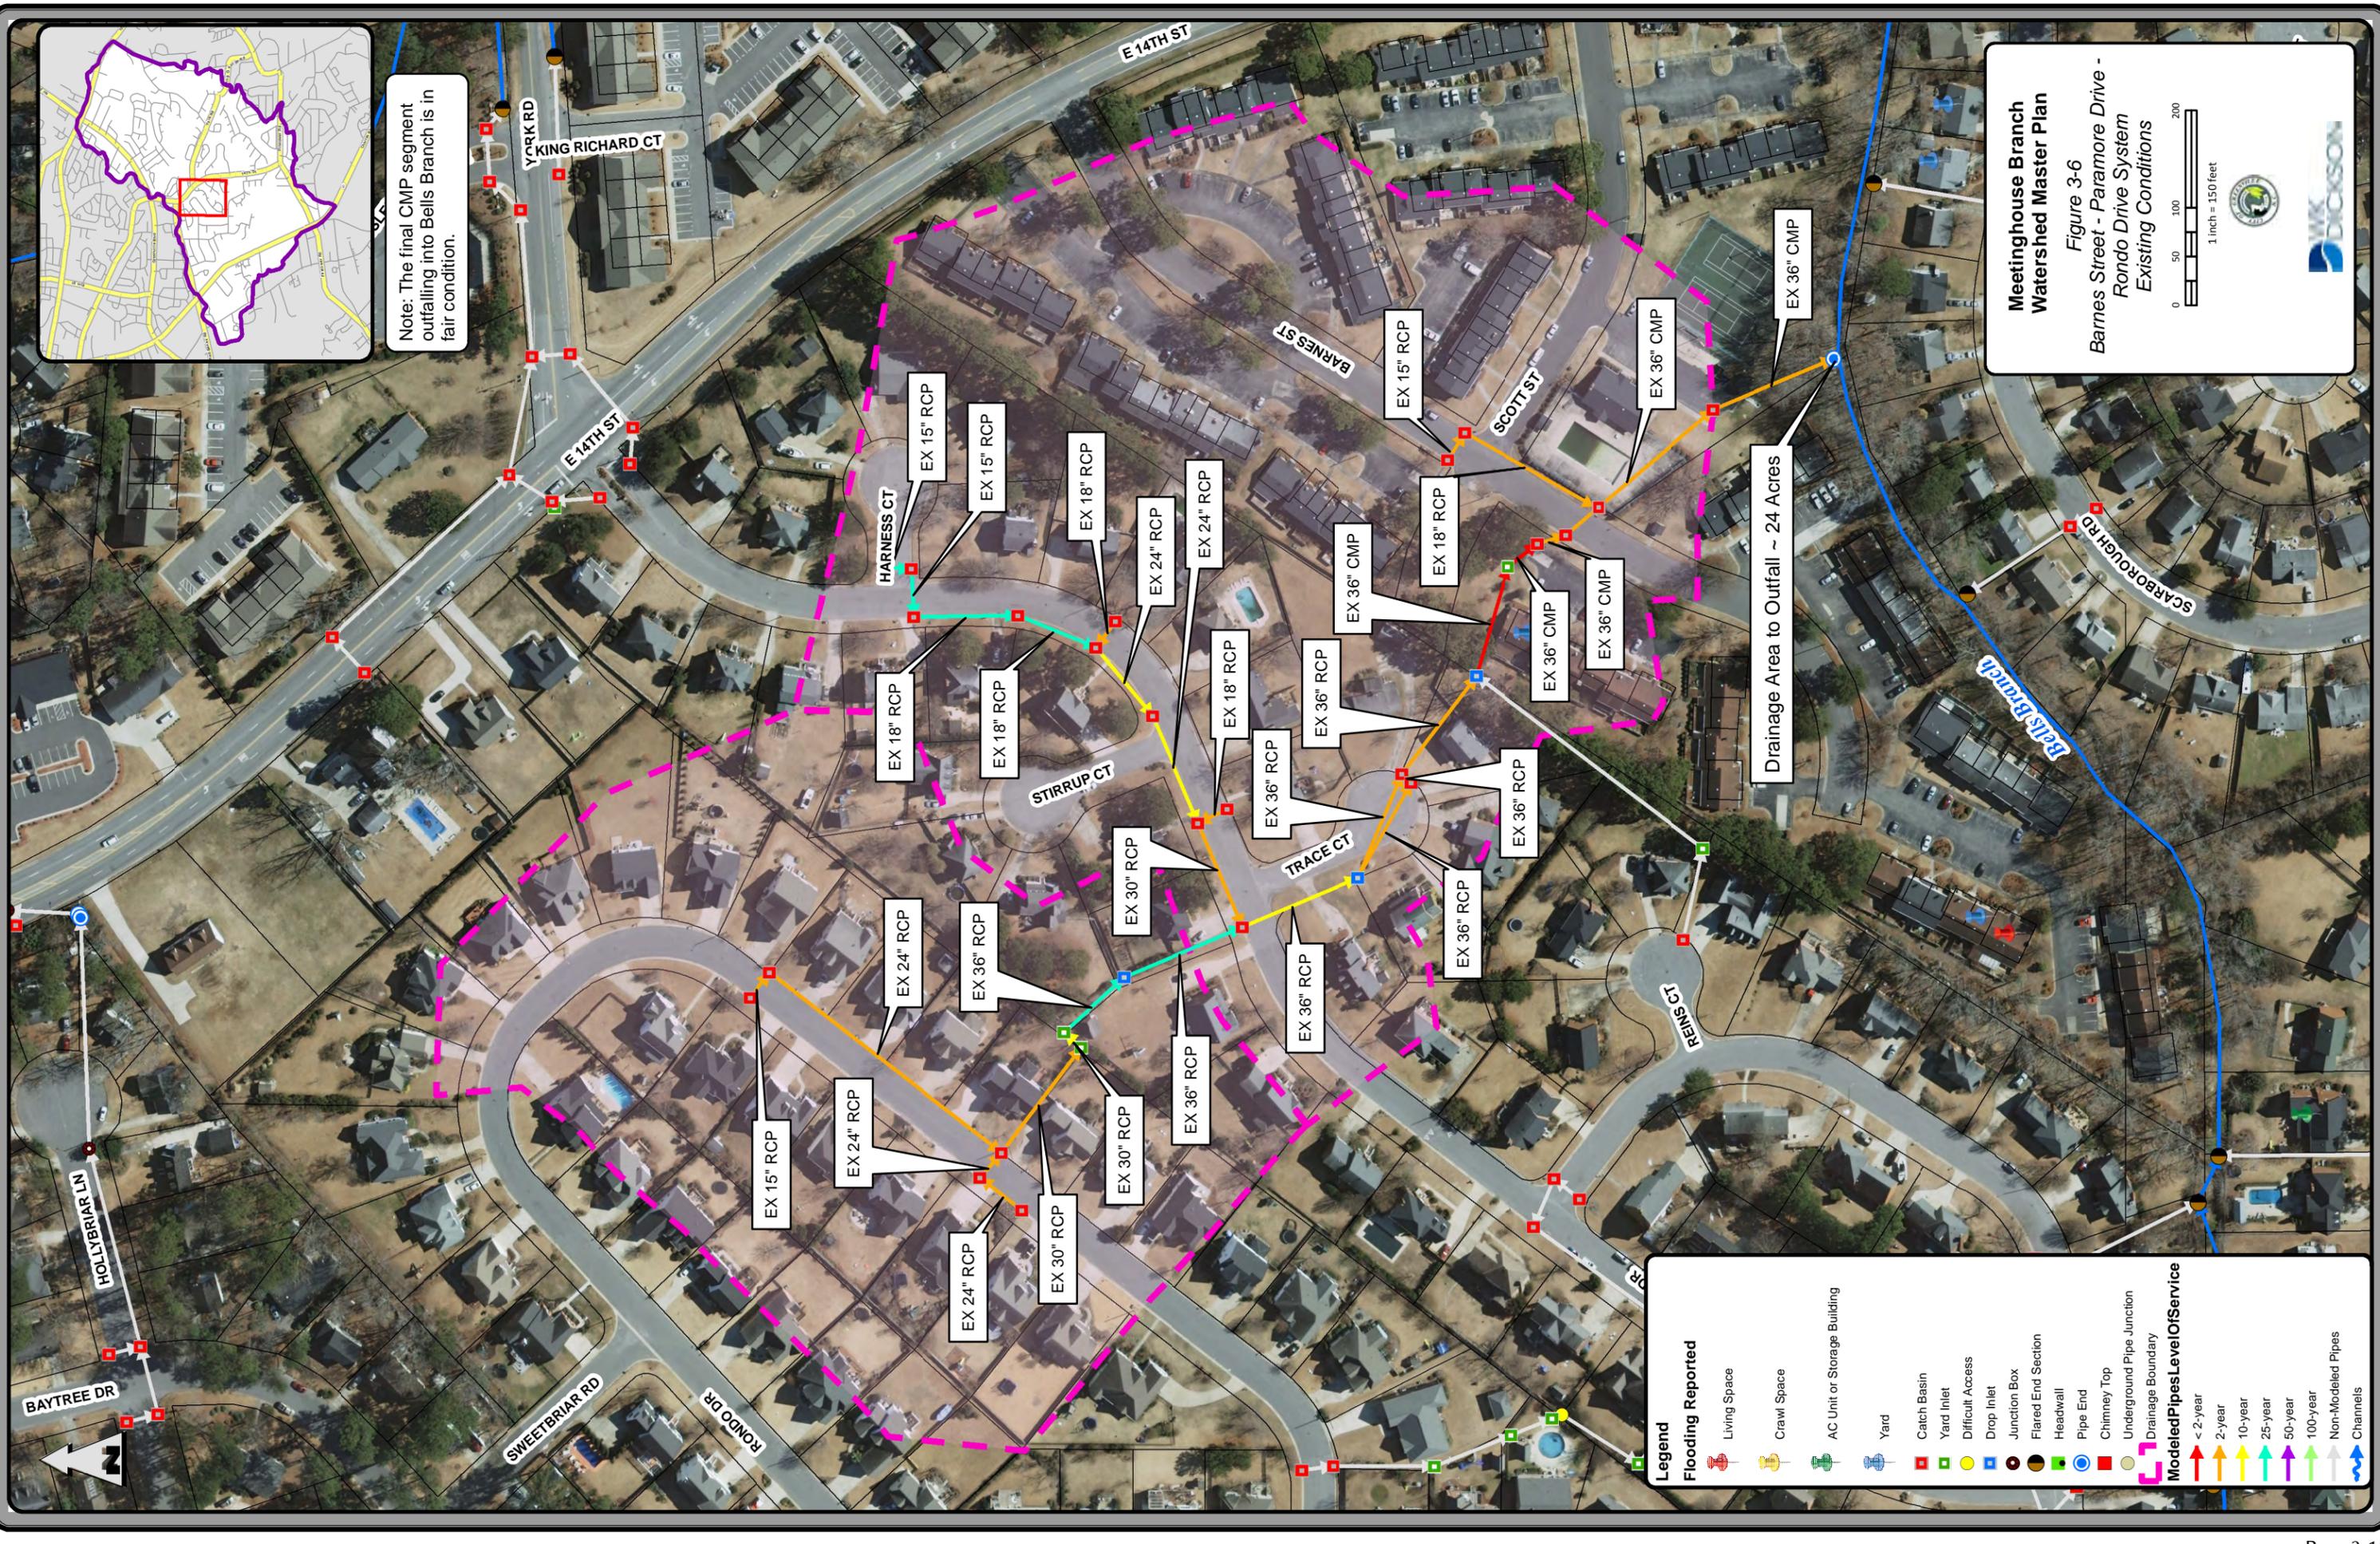
Meetinghouse Branch Watershed Master Plan
 Figure 3-6
 Barnes Street - Paramore Drive - Rondo Drive System
 Existing Conditions

Note: The final CMP segment outfalling into Bells Branch is in fair condition.

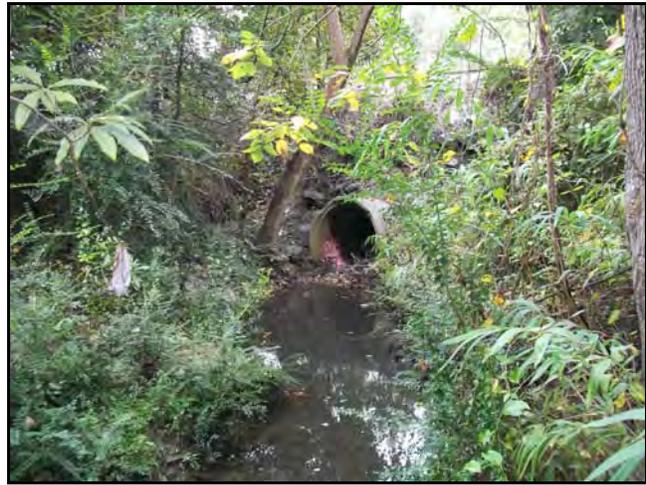
Picture 4-1. Downstream Invert - Railroad Culvert Crossing (Bells Branch)

The Railroad Crossing presents a unique set of constraints including access limitations. As shown in Picture 4-1, the Railroad Crossing is located in a wooded area. The railroad will need to remain in service therefore it is assumed that tunneling techniques such as jack and bore will be utilized to install the proposed floodplain culverts. In order to gain access for installing the proposed floodplain culvert, trees must be removed. The installation of construction staging areas and entrances will require additional tree removal and temporary construction easements. There are also sanitary sewer lines located adjacent to the Railroad Crossing that may need to be replaced or relocated.

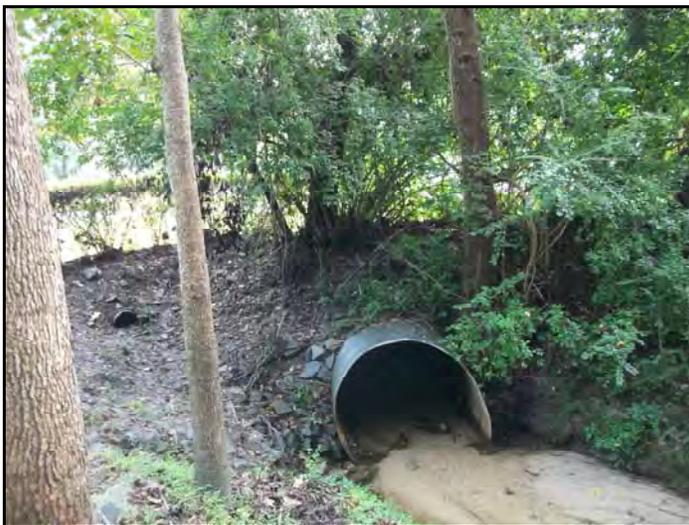
There were several other potential site restrictions and utility conflicts that were identified during a field visit including sanitary sewer lines that may need to be replaced or relocated. Impacts to traffic flow along Oxford Road during construction were also considered. Oxford

Picture 4-3. Upstream Invert – Oxford Road Closed System (Bells Branch)

Oxford Road – The closed system located at the downstream end of Bells Branch is undersized. It is currently operating below a 2-year level of service. Portions of the system are in poor condition requiring the City to perform frequent maintenance due to the formation of sinkholes in the right-of-way. Until the system is replaced the potential for sinkhole formation will remain which will result in a public safety hazard to motorists and residents in the area. It is proposed that the existing 60" CMP be replaced with 7' x 5' reinforced concrete box culvert (RCBC) to provide the desired 10-year level of service.

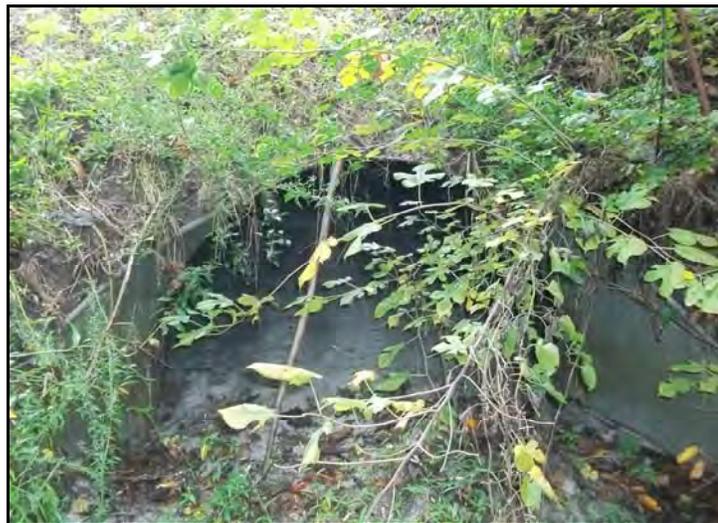
Tucker Drive – As determined by the existing conditions analysis, the existing 60” and 72” CMP culverts at this crossing do not meet the desired 25-year level of service. The culverts are in good condition but the opening of the 60” CMP is currently obstructed by sediment deposits. As shown in Picture 4-4, the pipe is over 50 percent blocked thereby reducing the

Picture 4-4. Obstruction at Tucker Drive Culvert Crossing (Meetinghouse Branch)

pipe capacity. If this culvert is cleaned out and able to flow at full capacity, it will provide a 25-year level of service. Therefore, it is recommended that the 60" CMP be cleaned out. No additional improvements are proposed at this location (See Figure 4-5).

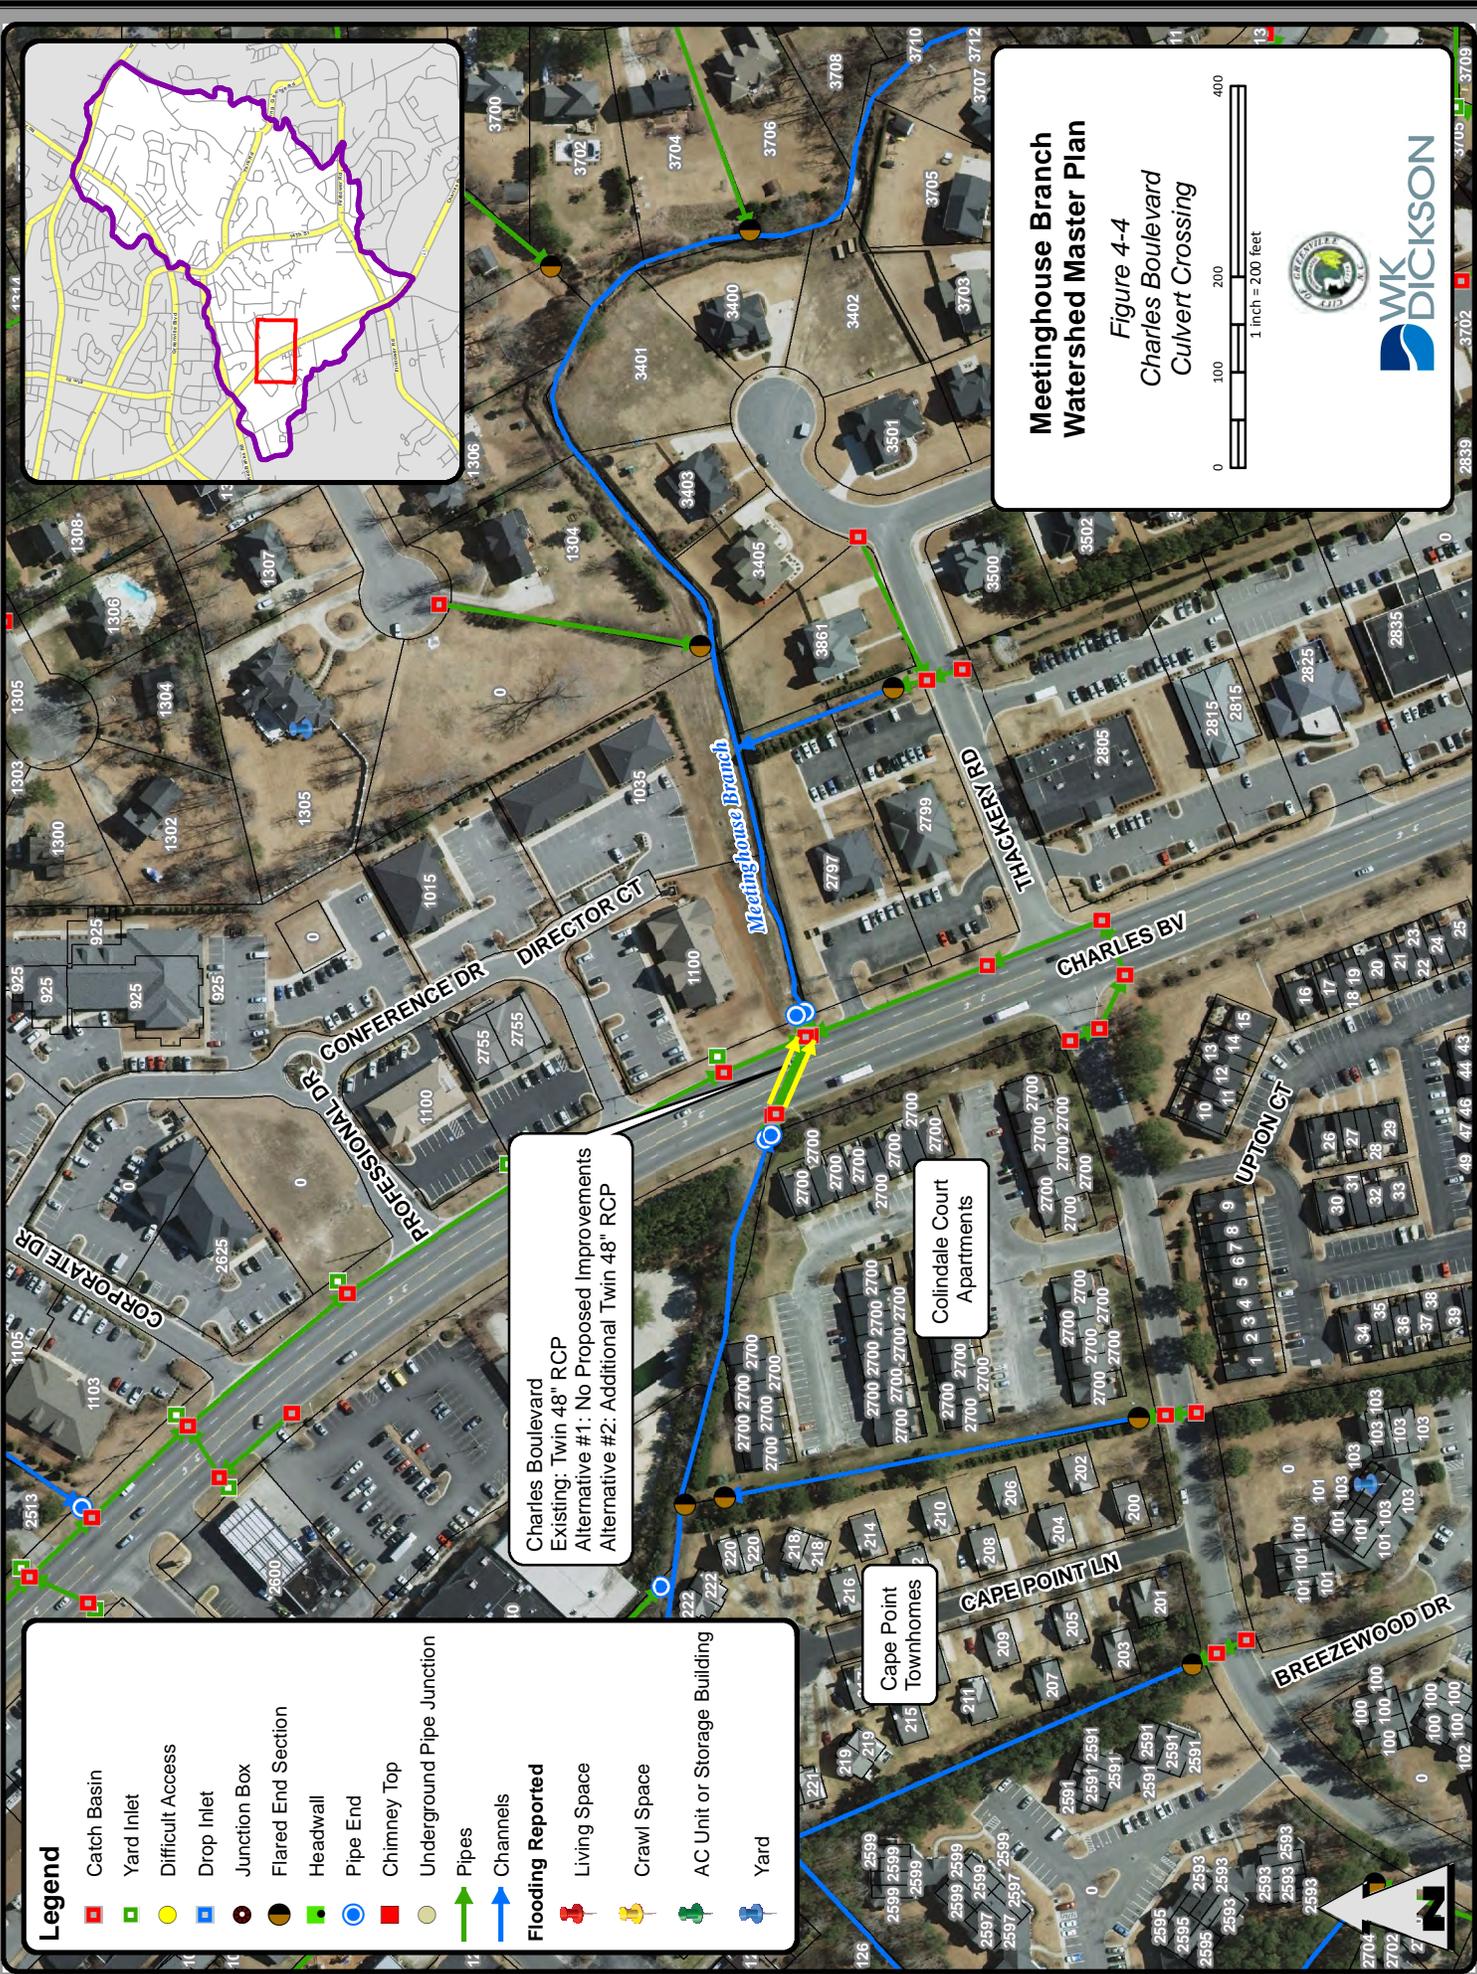
Figure 4-4
Charles Boulevard
Culvert Crossing

Charles Boulevard
Existing: Twin 48" RCP
Alternative #1: No Proposed Improvements
Alternative #2: Additional Twin 48" RCP

Alternative 2 includes installation of two additional 48" floodplain culverts. To provide a 50-year level of service at the crossing and to significantly reduce water surface elevations in the Colindale Court Townhomes located immediately upstream of the culverts. In existing conditions 7 townhomes at this location are potentially floodprone during the 25-year storm event and over 50 townhomes/apartments are at risk of flooding during the 100-year event. At a minimum the parking areas are likely flooded on a frequent basis. The proposed Alternative 2 improvements would decrease flood elevations upstream of the culvert in excess of 1 foot during the 25-year storm.

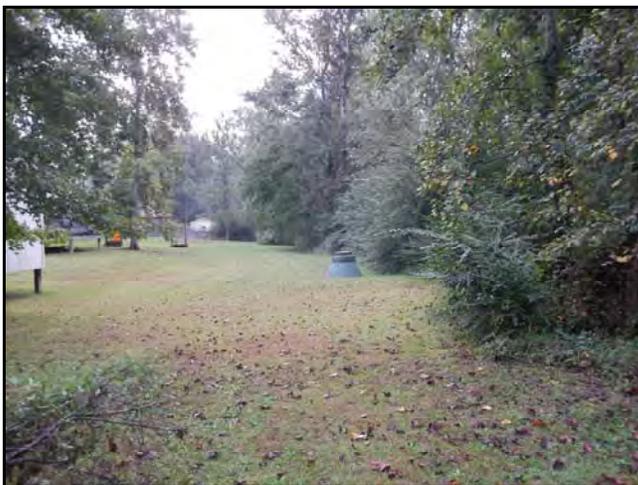
During a field inspection, there were several potential site restrictions and utility conflicts identified including overhead power lines that are located above the 14th Street culvert. There also appears to be sanitary sewer lines that may need to be replaced or relocated. Impacts to traffic flow during construction were considered. This section of 14th Street is a two-lane roadway. It is anticipated that a road closure or a flagged two-way one-lane operation will be required. Alternative #2 included additional impacts from the construction of the floodplain

Picture 4-5. Left Overbank – Proposed Location of 14th Street Floodplain Bench (Meetinghouse Branch)

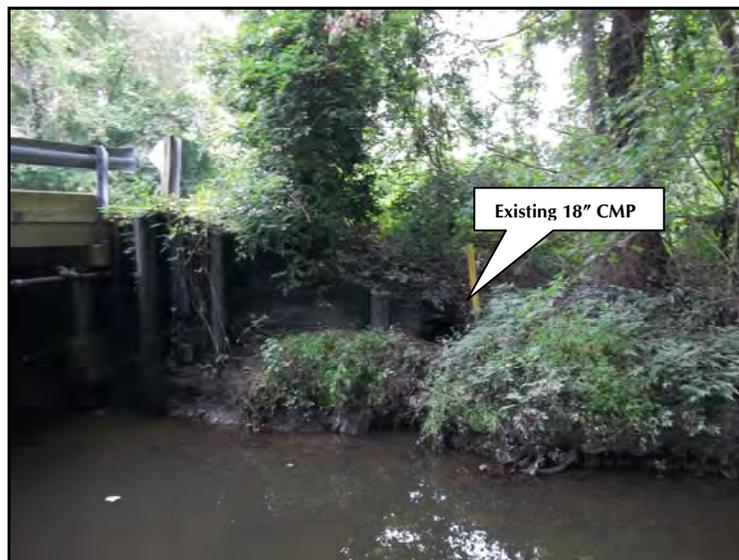
Picture 4-6. Downstream Right Wingwall - Oxford Road North Bridge
(Meetinghouse Branch)

- Install 20 linear feet of curb and gutter on the southern side of the bridge along with two inlets;
- Raise the existing curb and gutter to be flush with the bridge on the northern side; and
- Relocate the existing 18" CMP away from the bridge wingwall (See Picture 4-6).

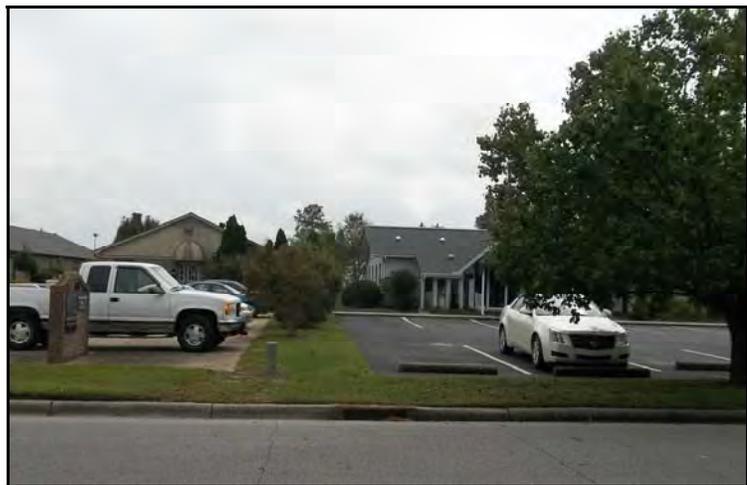
The project will cause significant impacts to private property. The proposed improvements include upsizing segments of pipe between 105 and 107 Oakmont Drive and further downstream between 136 Oakmont Drive and 140 Oakmont Drive. These sections will involve construction in narrow corridors with limited space. This may require additional costs to protect the foundations of the adjacent properties (See Picture 4-7).

Picture 4-7. Area between 105 and 107 Oakmont Drive

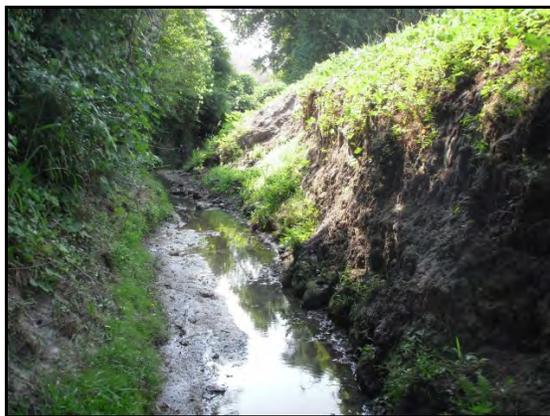
Picture 5-1. Downstream view of bank erosion and sparse vegetation

Based on the basin wide stream assessment completed as described in Section 3.3, five (5) stream stabilization projects were identified to help reduce instream erosion. Instream erosion can be a significant source of sediment that ultimately can impair the biodiversity of the

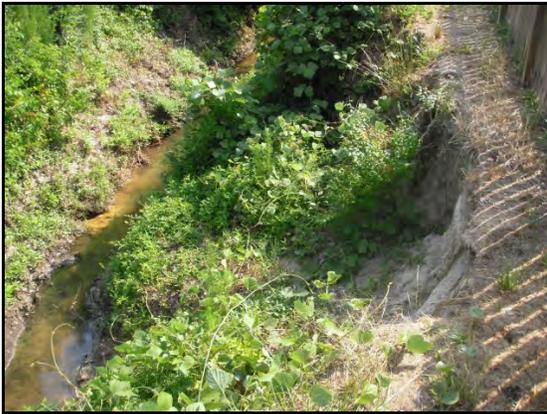
Picture 5-2. Severe bank erosion along landscaping fence

Stream Stabilization Project #1 – Charles Boulevard – The Charles Boulevard project begins on Meetinghouse Branch immediately downstream of Charles Boulevard. As shown on Figure 5-1, the project begins at the culvert crossing and continues downstream for approximately 650 linear feet. The Charles Boulevard project is a second order perennial section of Meetinghouse Branch and has a drainage area of 114 acres. Land use surrounding this project consists mainly of small business offices and residential houses. The proposed project reach flows west to east and is confined within a steep eroded channel feature. The bottom width (streambed) is approximately 3 to 4 feet wide. Both left and right banks are nearly 10 feet tall and have bank angles of 70 degrees. The average top channel width is 15 feet wide. This channel does not have a forested buffer making it highly susceptible to bank erosion. Herbaceous bank vegetation is dominant throughout and is being overtaken by the invasive species kudzu (*Pueraria montana*). Bank conditions are currently unstable and eroding at an accelerated pace due to loamy sand soil texture and lack of sufficient bank vegetation. Another factor contributing to erosion and down cutting of the streambed is the high flow velocity from flashy storm events. In some locations along the project reach, right bank erosion is extreme enough that it reaches landscape fences in adjacent property owners’ lawns (See Picture 5-2).

The proposed project reach has opportunities for bank stabilization to prevent sediment loading and bank erosion to Meetinghouse Branch. Open lawn areas adjacent to this stream segment would make this project accessible. To improve bank stability and reduce bank erosion along the proposed reach, several tasks need to be performed. Bank erosion can be reduced by grading channel banks back to a minimum 2 to 1 slope and placement of coir erosion control matting along banks and bare areas. Live staking

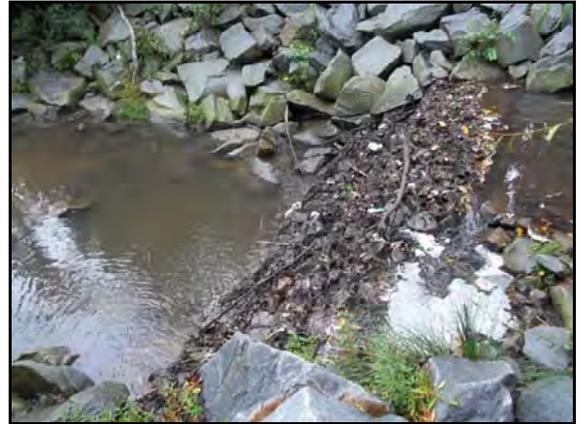
Picture 5-3. Existing rock drop structure

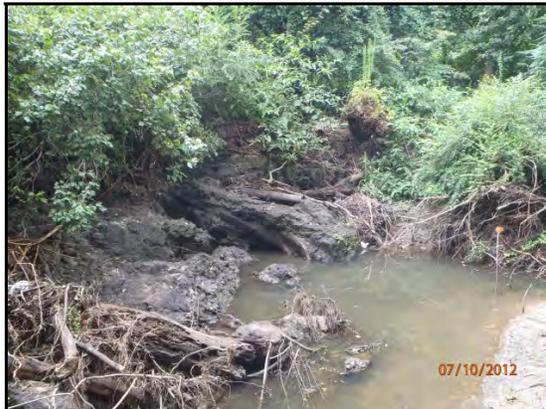
The surrounding land use of the Crooked Creek Road project consists entirely of residential houses. This stream segment of Meetinghouse Branch flows from the southwest to the northeast with an average stream width of 5 feet. The depth ranges from 0.3 to 2.5 feet deep. Throughout this stream project, bank height varies with stream depth and the severity of erosion. On average the right bank is 12 feet high and the left bank is 9 feet. The proposed project reach has a young forested buffer along the right bank, and the left bank is mainly residential lawns with few trees and shrubs. Vegetation within the project area consists of red maple (*Acer rubrum*), laurel oak (*Quercus laurifolia*), sweetgum (*Liquidambar styraciflua*) and Chinese privet (*Ligustrum sinense*). Bank conditions are currently unstable and eroding at an accelerated pace due to loamy sand soil texture and lack of sufficient bank vegetation. In some locations along the Crooked Creek Road project, right bank erosion is extreme enough that it has caused bank failures and trees to fall into the stream creating debris jams. Debris jams may cause further bank instability and potential property flooding. Bank erosion is present along the left bank, as

Picture 5-4. Severe bank erosion along right bank causing bank failures and trees to fall

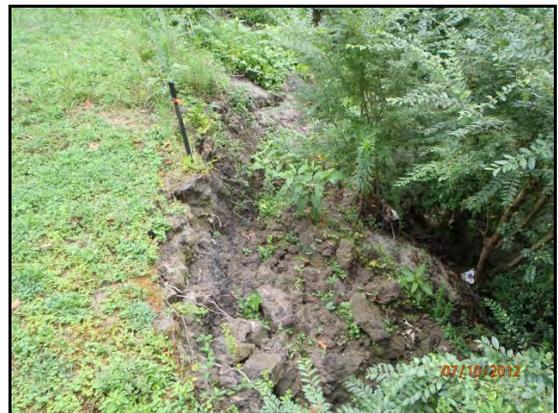
Picture 5-5. Left bank erosion adjacent to residential lawns without stream buffer

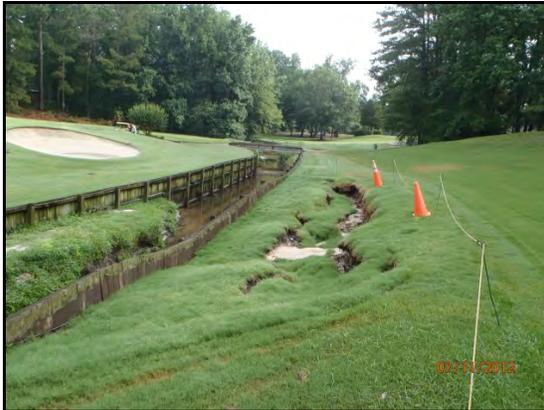
Picture 5-6. Right bank area sinking behind retaining wall along the Brook Valley Golf Course Project

The proposed project is located entirely on the Brook Valley Country Club Golf Course. This stream segment of Meetinghouse Branch flows northeast and has an average stream width of 6 feet. This stream ranges from 0.2 to 3.0 feet deep. For nearly 200 linear feet, the stream is confined to a wooden retaining wall. This section is relatively stable; however, there is a section on the right bank approximately 35 linear feet long that is sinking behind the retaining wall as shown in Picture 5-6. Just below the cart path bridge where the wooden retaining wall ends, the stream is eroding on both banks. This segment is 110 linear feet long. Erosion in this location is caused by the

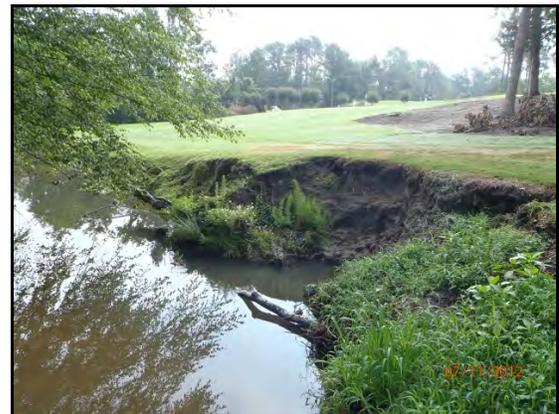
Picture 5-7. Vertical right bank erosion near the downstream end of the proposed project reach.

The proposed stream reach noted above has potential for bank stabilization to prevent sediment loading and bank erosion to Meetinghouse Branch. This project can be easily accessed from the golf course without any constraints. Bank stability along the Brook Valley Golf Course project can be obtained by performing several tasks. Stream banks that lack a forested buffer and are not confined within the wooden retaining wall should be stabilized by grading channel banks back to a minimum 2 to 1 slope and placing coir erosion control matting and planting live stakes along banks and bare areas. The banks should be reinforced with rip-rap along bends and meanders to prevent bank failures in the future. Another option for stream segments within the golf course playing area is to stabilize with additional wooden retaining walls similar to the

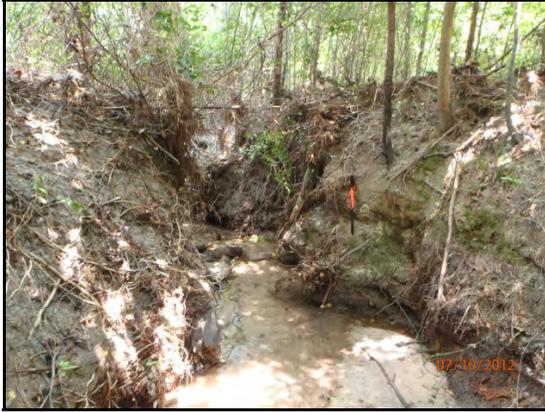
Picture 5-8. Down cutting and steep bank angles typical throughout the proposed project reach.

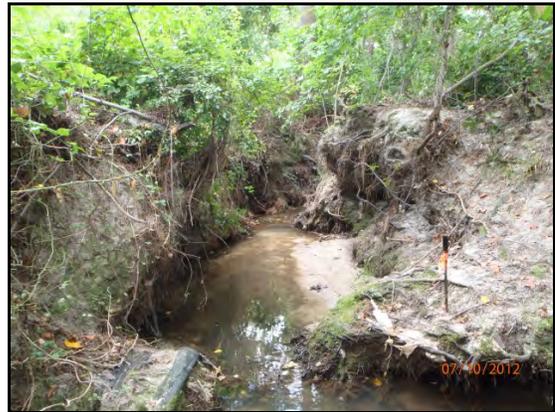
Picture 5-9. Undercut banks and erosion at the downstream section of the proposed project reach.

The proposed project reach described above is a good candidate for bank stabilization. This project has few constraints limiting access. There is a sanitary sewer line crossing at the bottom of this reach so access can be gained through the existing easement. Bank erosion can be reduced by grading channel banks back to a minimum 2 to 1 slope, placing coir erosion control matting along banks and bare areas, and planting live stakes. To prevent additional down cutting of the streambed, log grade control structures can be added. The entire project area should be treated for invasive species and planted with a permanent riparian seed mix.

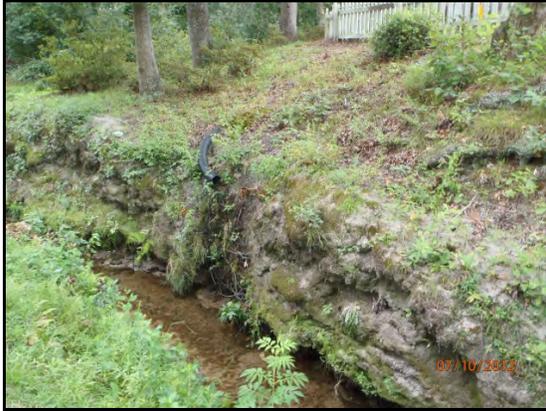
Picture 5-10. Vertical left bank erosion on the proposed project reach.

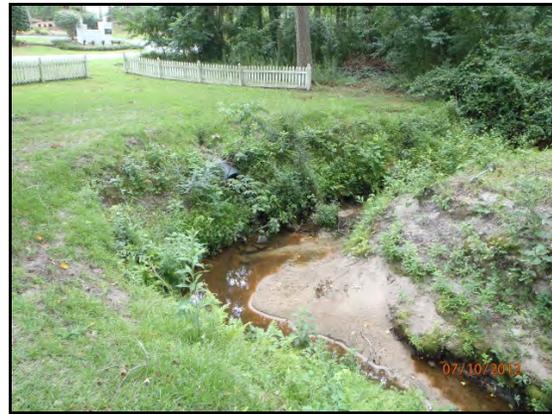
Picture 5-11. Stream meander bends with absence of bank protection and buffer

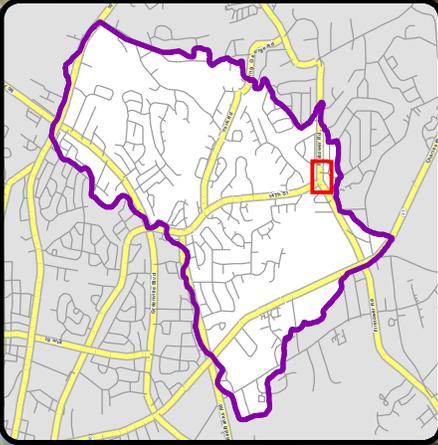
Figure 5-8
Eleanor Street Bioretention Area

- Install a bioretention area designed to treat runoff from the adjacent parking lot. The proposed impervious areas draining to the proposed area is 0.35 acres.
- Grade to provide positive drainage from the parking lot to the proposed bioretention area.
- Install a yard inlet with an 18" outfall pipe directing flow into existing grass swale and ultimately to closed system along East Firetower Road.

The required surface area for the proposed bioretention area is approximately 1,230 square feet (0.03 acres). A concept level plan of the proposed improvements is shown in Figure 5-8. The proposed Eleanor Street bioretention project consists of the following improvements:

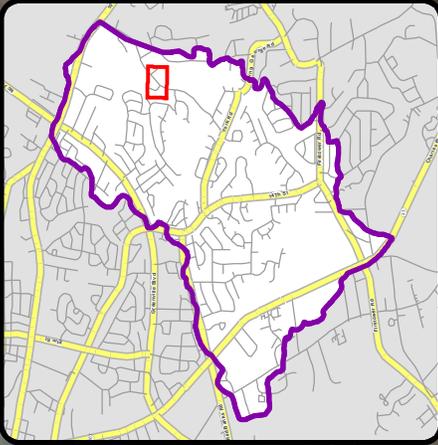
Figure 5-9
Brook Valley Country Club
Bioretention Area

- Install a bioretention area designed to treat runoff from the adjacent tennis court, Oxford Road, and the redirected pool house roof leaders. The proposed impervious areas draining to the proposed area is 0.35 acres.
- Install a yard inlet with an 18" outfall pipe directing flow into Meetinghouse Branch.

The required surface area for the proposed bioretention area is approximately 1,200 square feet (0.03 acres). A concept level plan of the proposed improvements is shown in Figure 5-9. The proposed Brook Valley Country Club bioretention project consists of the following improvements:

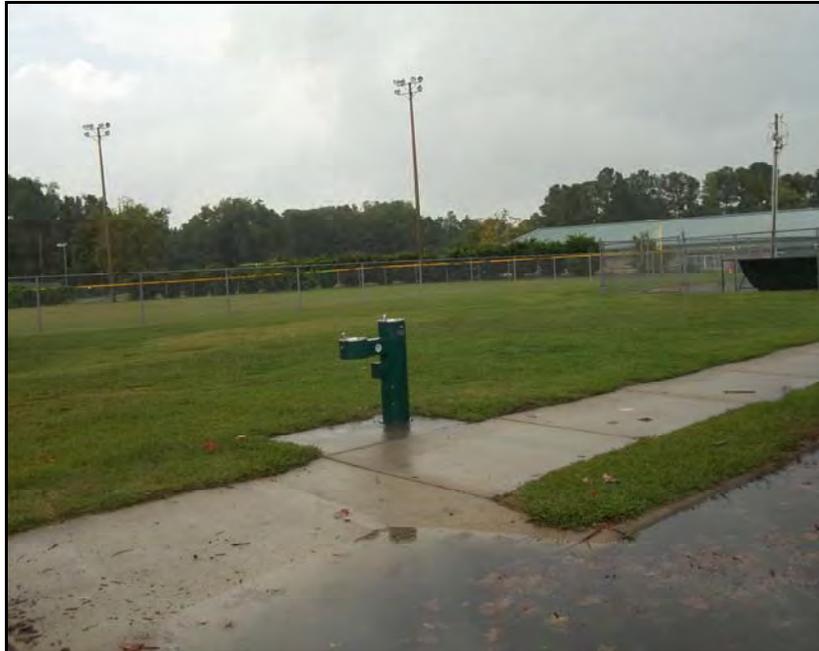
Picture 5-19. Proposed Location for Jaycee Park Bioretention Area

A potential bioretention project site is located between the Jaycee Park baseball field and parking lot. There is a grassy area shown in Picture 5-19 that could be used to capture and treat the runoff from the parking lot. The parking lots currently drain to the closed system along Cedar Lane. In addition to the bioretention area, it is recommended that concrete curb cuts be installed in the northeastern portion of the parking lot to allow water to access the proposed bioretention area.

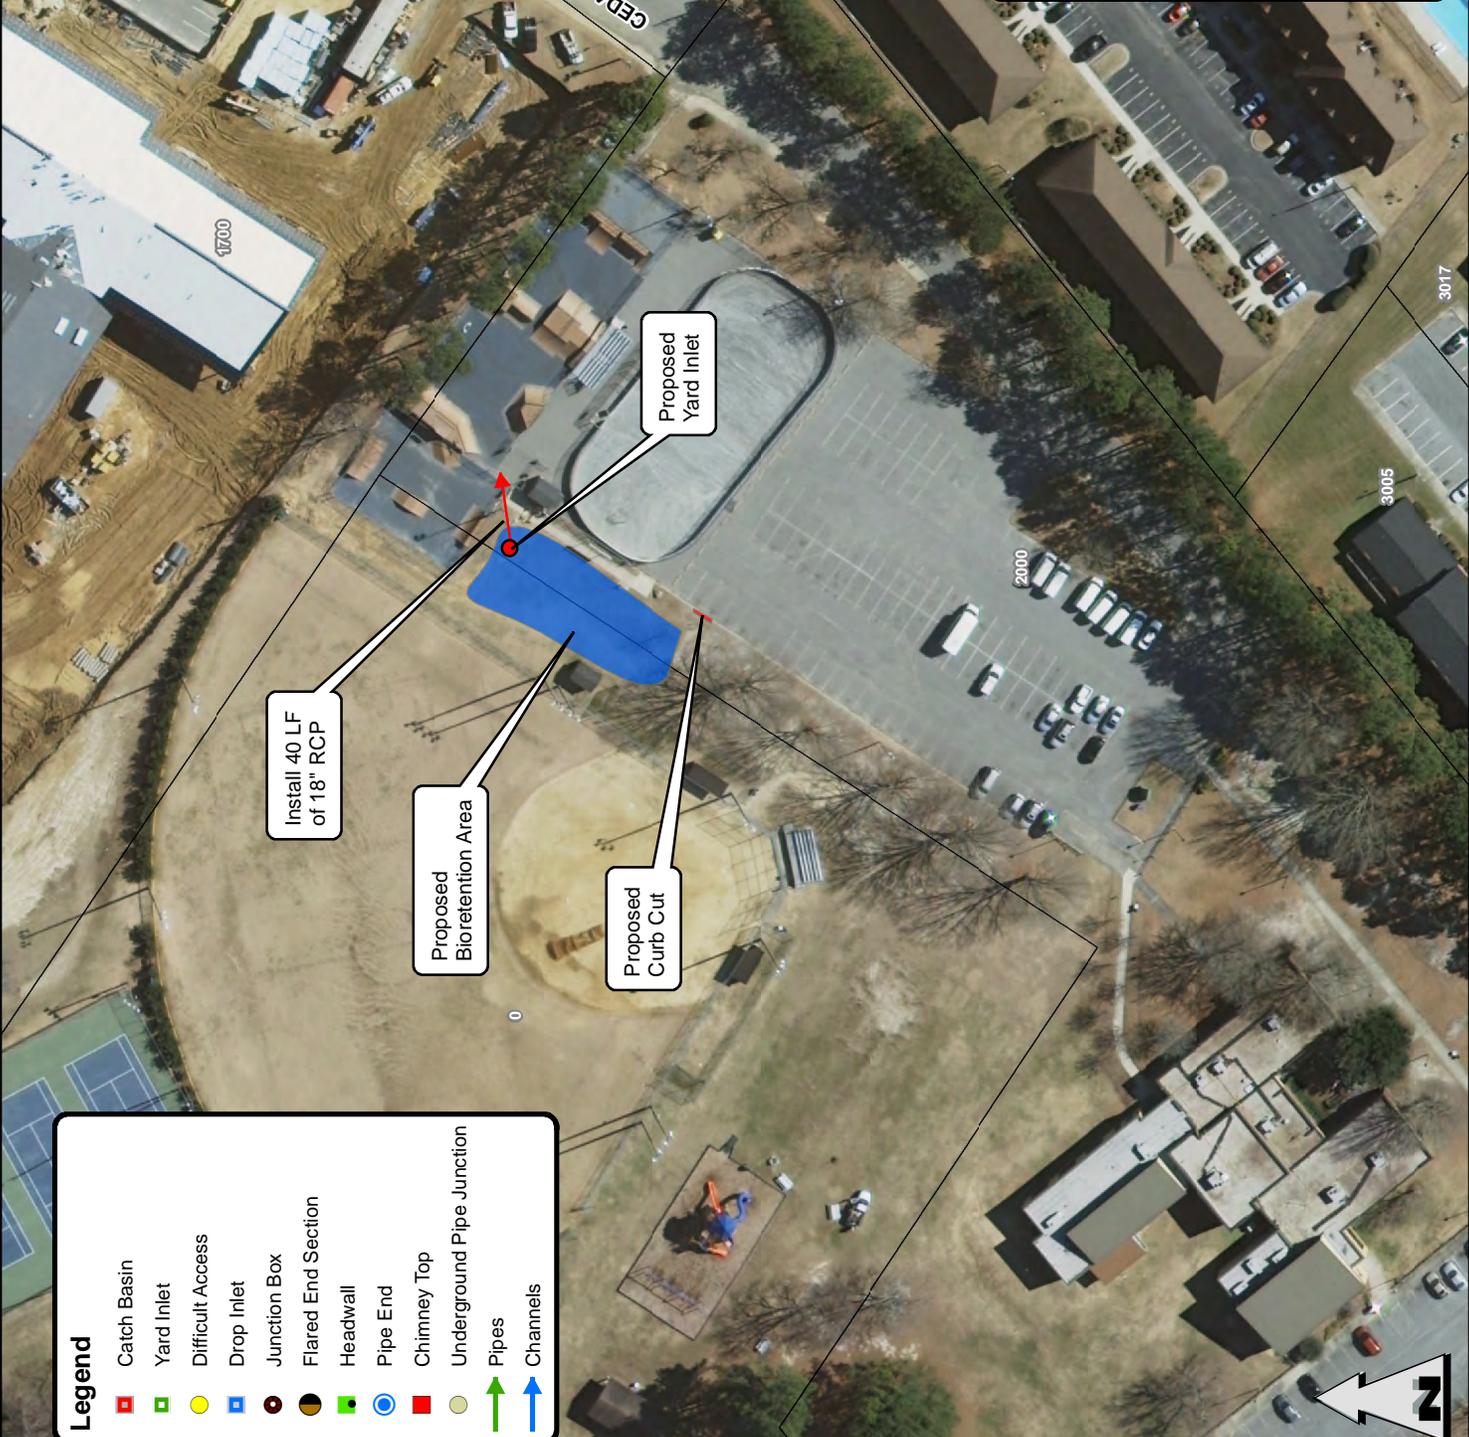
Figure 5-12
Jaycee Park
Bioretention Area

The required surface area for the proposed bioretention area is approximately 5,500 square feet (0.13 acres). A concept level plan of the proposed improvements is shown in Figure 5-12. The proposed Jaycee Park bioretention project consists of the following improvements:
